Fire Safety in buildings – Valencia and Grenfell similarities

What happened in Valencia?

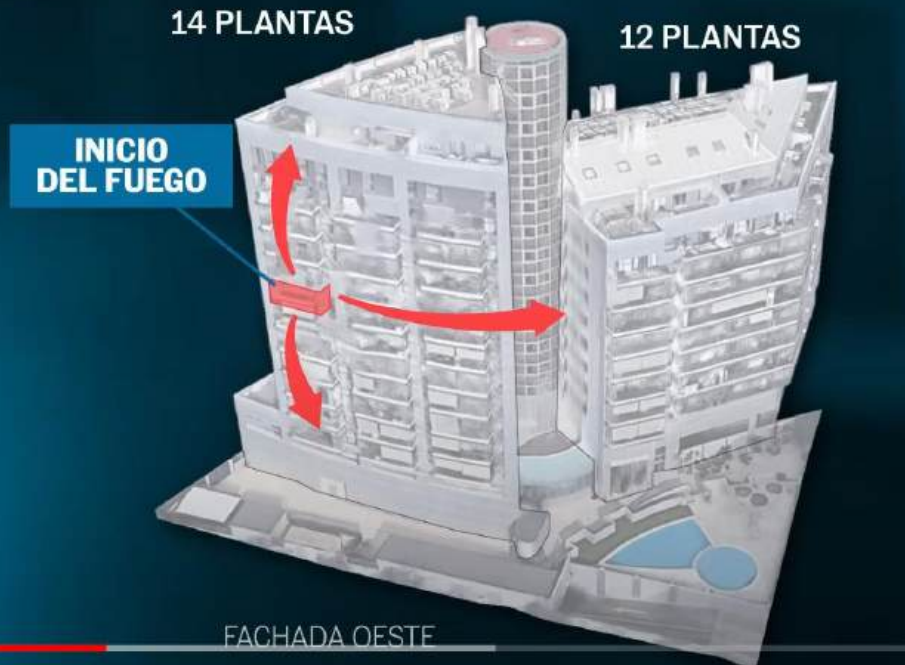
VALENCIA | Cronología del incendio: 24 horas contra el fuego | EL PAÍS
Extensión del fuego en el edificio

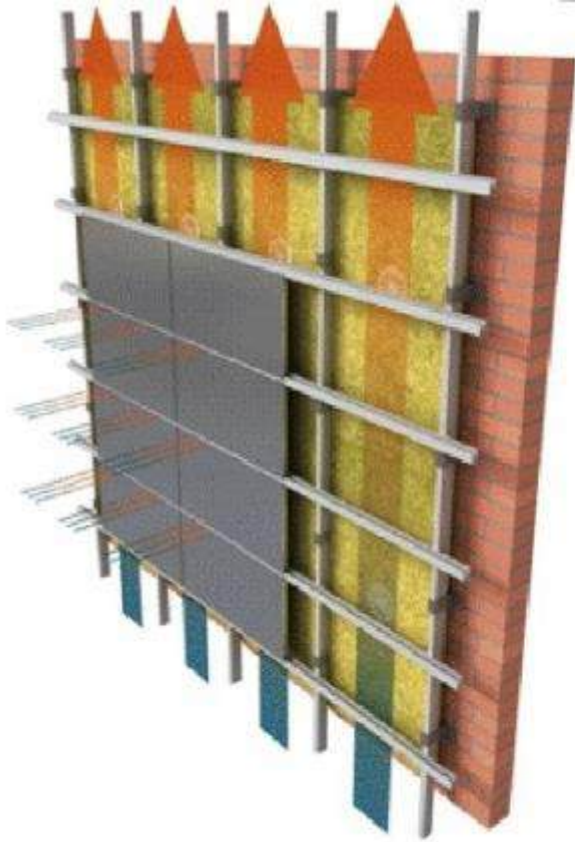
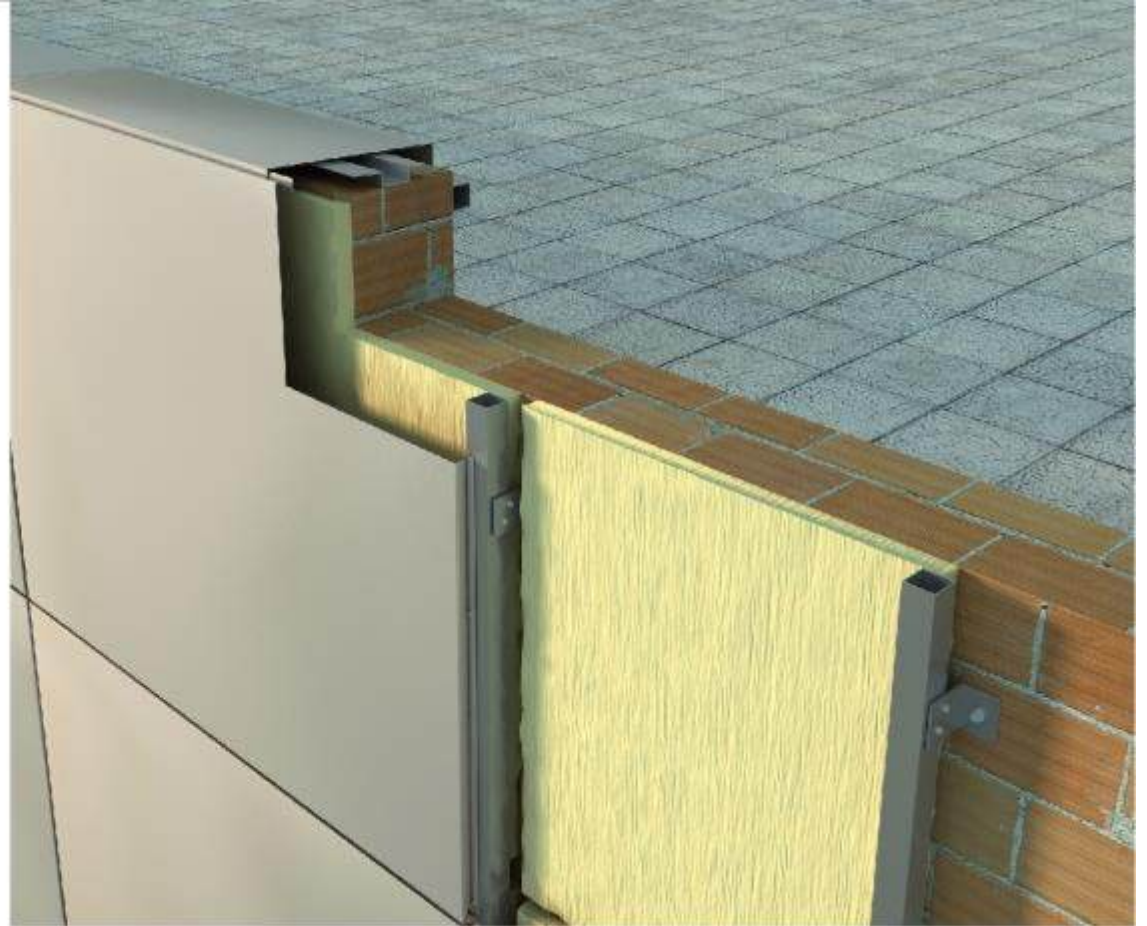
Same façade with PU in Grenfell and MW in Valencia

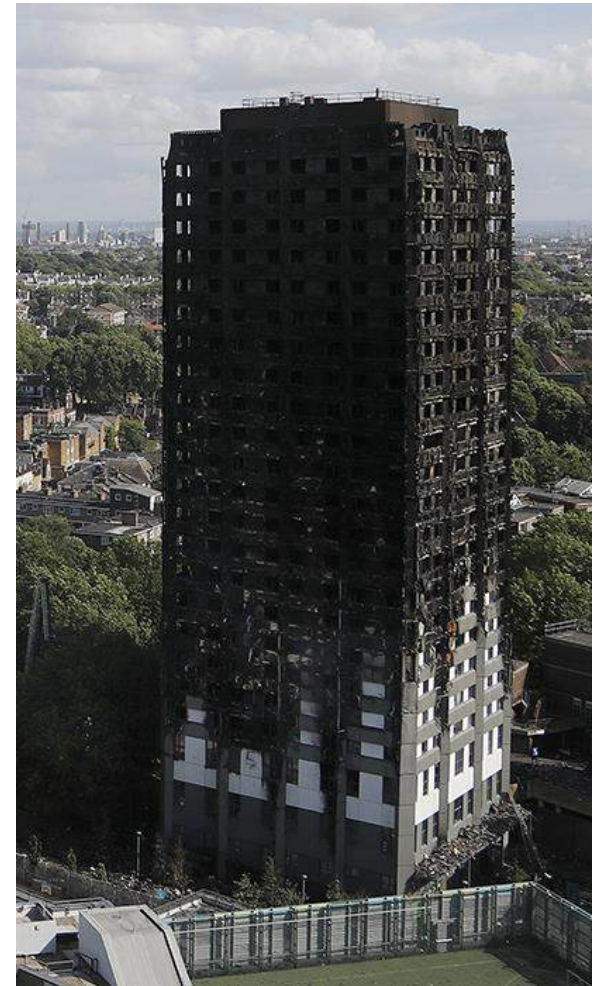
July 14th 2017 a fire destroyed the Grenfell Tower in London.

The fire started at the kitchen in an apartment on the 4th floor.

The fire ignited the apartment and spread through the window of the kitchen to the façade.

People stayed in their apartments due to the building policy.

This catastrophic event resulted in 71 fatalities.

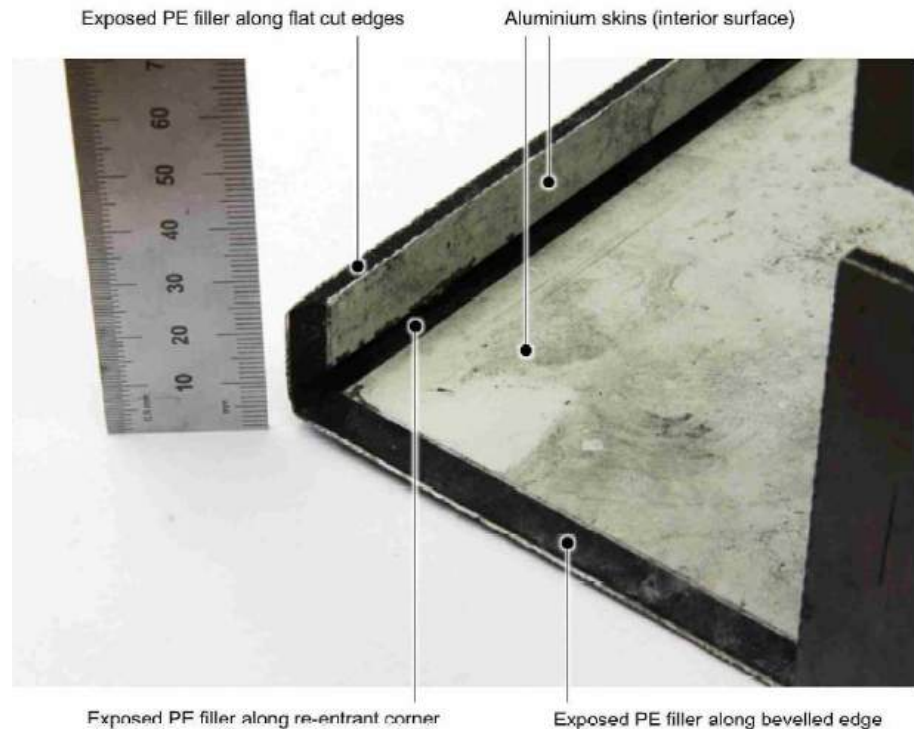
- The fire penetrated into the back of the cladding cavity and ignited the polyethylene filler material within the aluminium composite material (ACM).
- The primary cause of rapid and extensive external fire spread was the presence of polyethylene filled ACM clads installed during the retrofitting. Multiple cut edges were directly exposing the PE filler material.
