Fire Safety in buildings – Valencia and Grenfell similarities

What happened in Valencia?

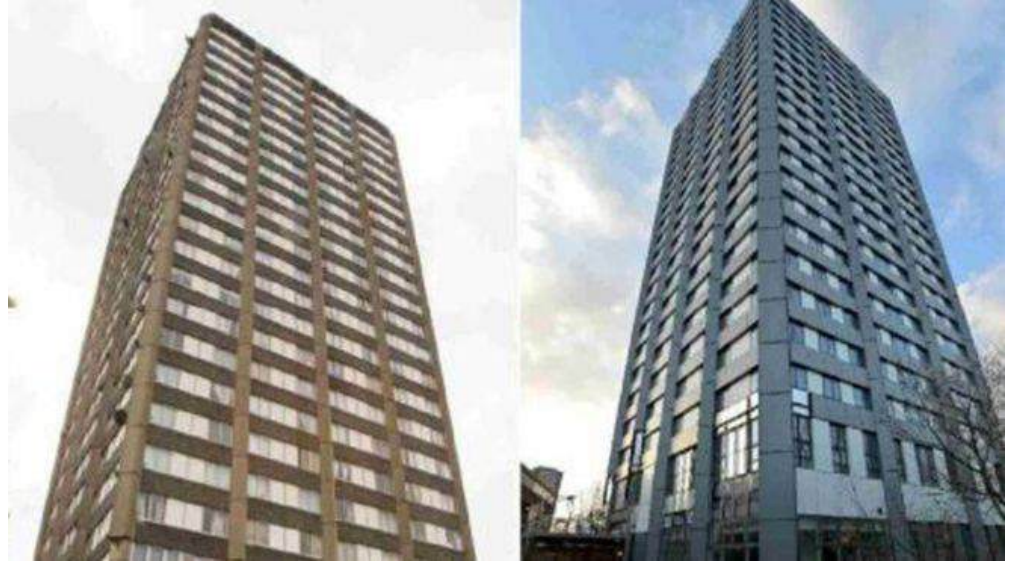
- Grenfell Tower was built in 1974, had 24 floors and 129 apartments.

- Between 2014 and 2016 the façade was renovated applying a ventilated cladding system with PU as insulation boards. The airgap was equipped with fire barriers and windows also replaced.

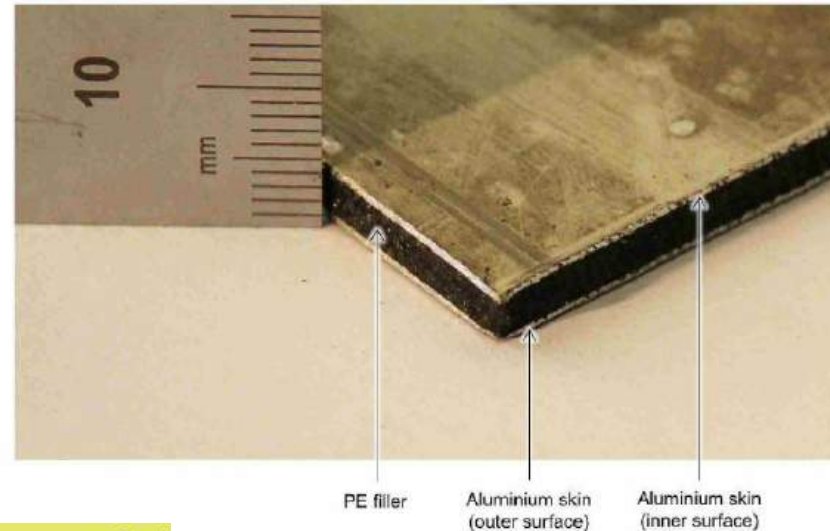
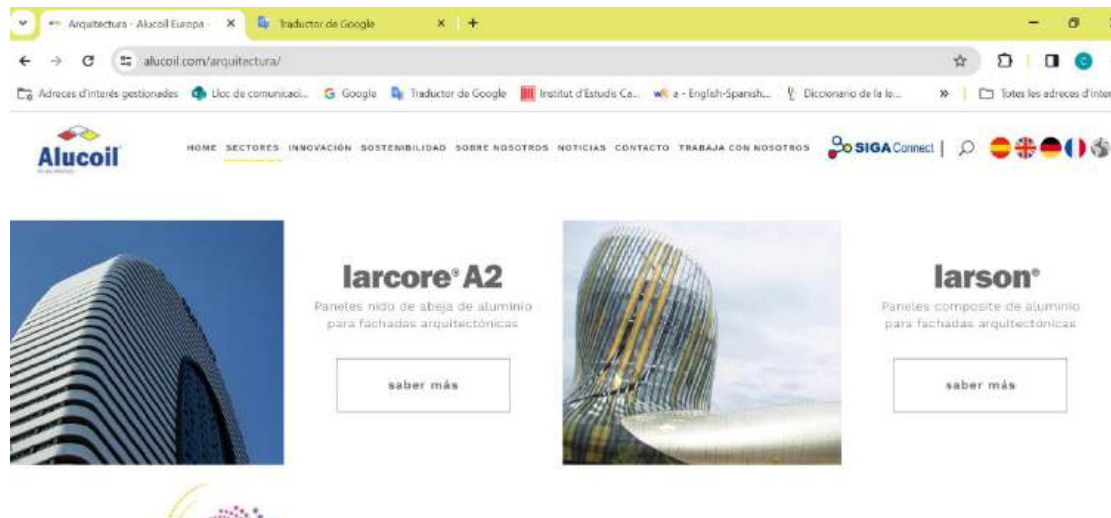
- Reynobond PE – Euroclass E (No fire classification provided testing due to enquiry)
- Reynobond FR (PE+FR) – Euroclass B-s1, d0
- Reynobond A2 core

- The fire penetrated into the back of the cladding cavity and ignited the polyethylene filler material within the aluminium composite material (ACM).
- The primary cause of rapid and extensive external fire spread was the presence of polyethylene filled ACM clads installed during the retrofitting. Multiple cut edges were directly exposing the PE filler material.
